OHIO RIVER BASIN
BROAD FORD RUN
GARRETT COUNTY,

NDI I.D. NO. MD 36

2 (BROADFORD RUN DAM)

PHASE I INSPECTION REPORT

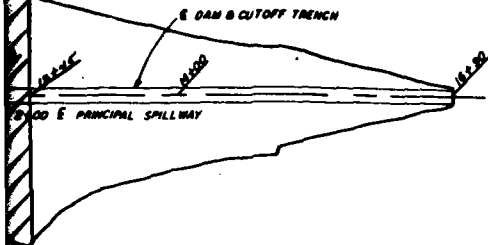
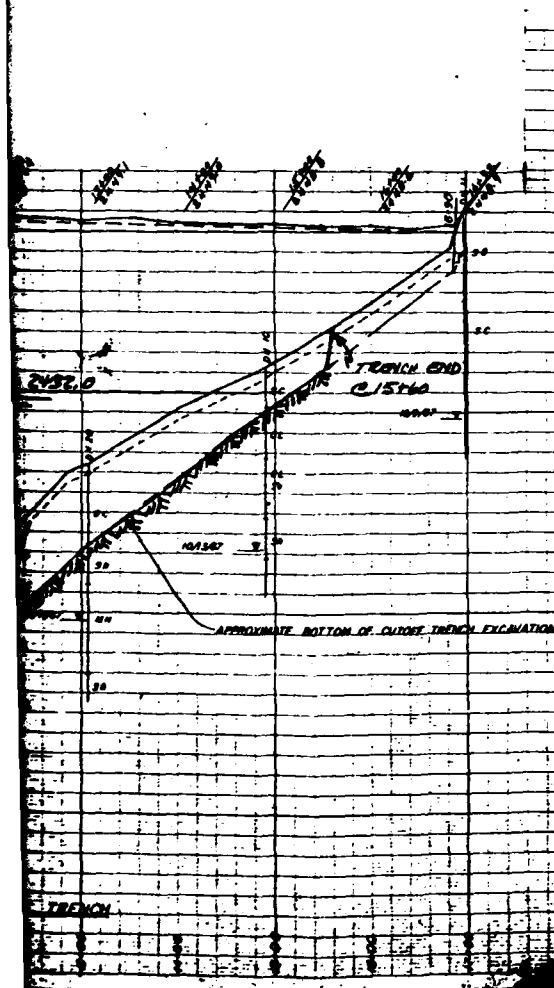
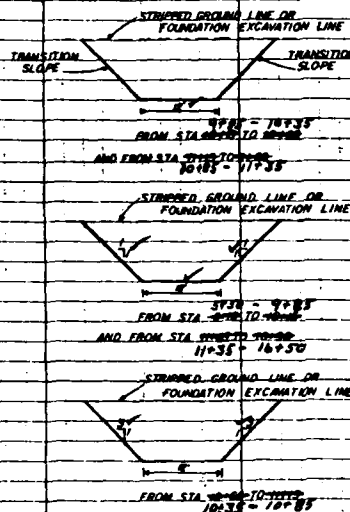
TYPICAL SECTIONS OF CUTOFF TRENCH
(Not to Scale)

A cutoff trench is located at the centerline of the dam embankment. The cutoff trench extends along the dam foundation and abutments up to about 18 ft. below the crest of the dam. (Refer to Plate No. 2.)
